# Waterside Workers Federation Hall (fmr) **CONSERVATION MANAGEMENT PLAN**

11 Nile Street,  
Port Adelaide

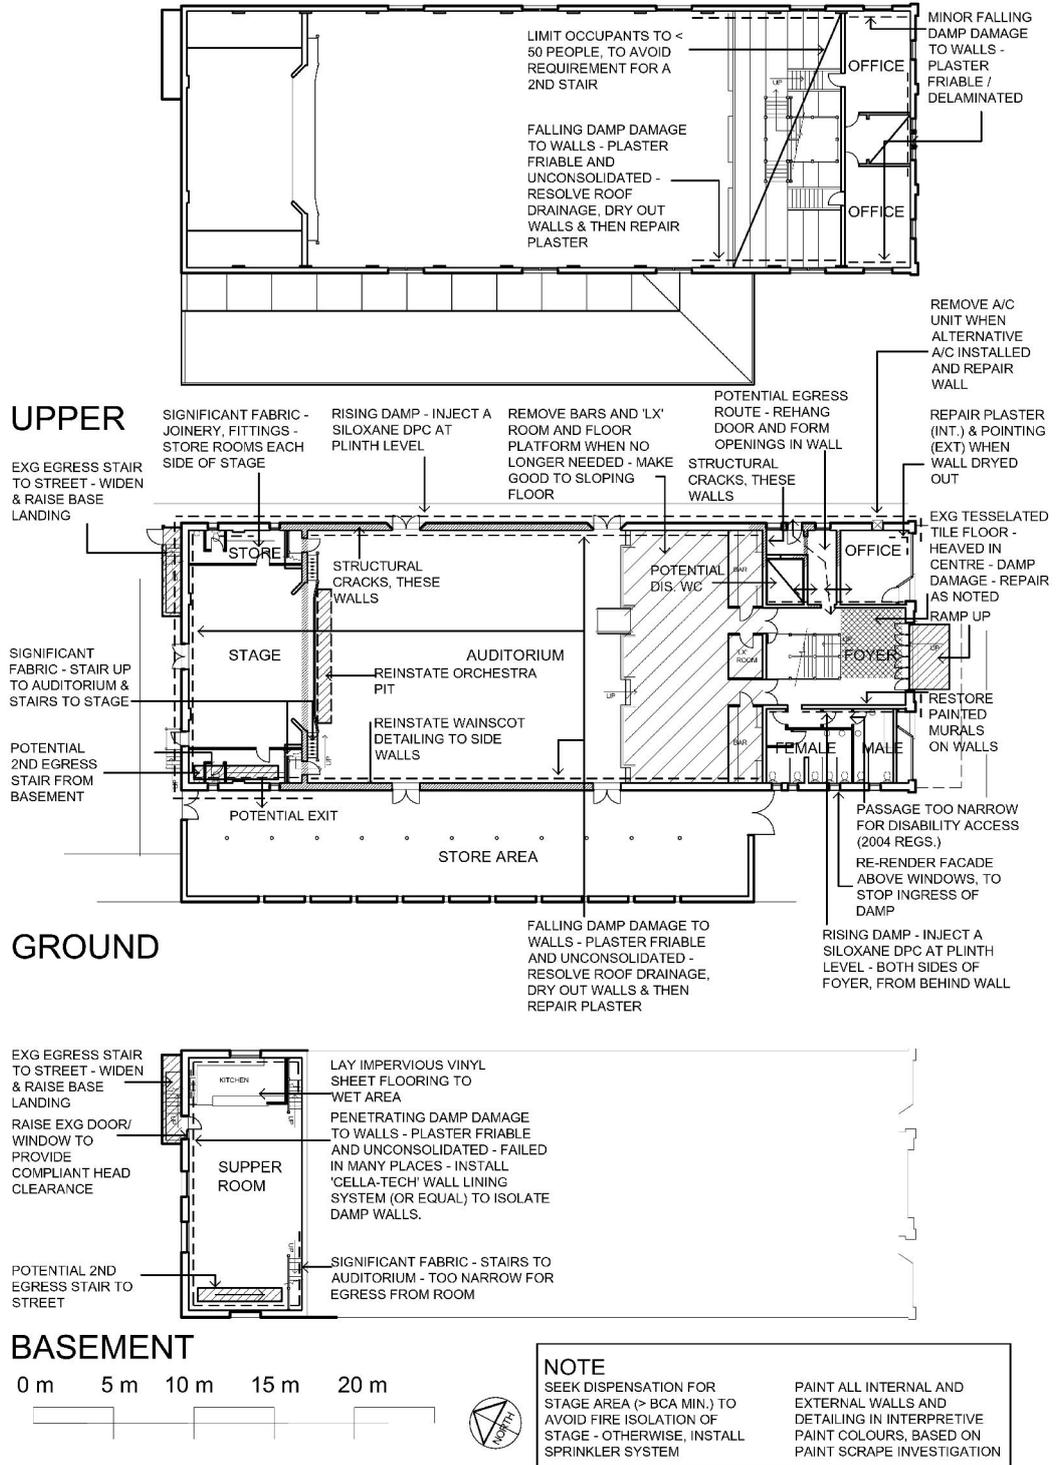
## Waterside Workers Federation Hall (fmr) Conservation Plan

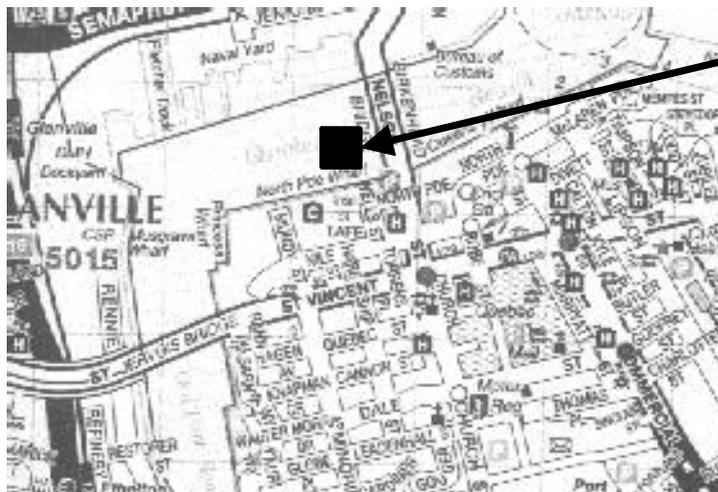
*Location of Waterside Workers Federation Hall, 11 Nile Street, Port Adelaide*

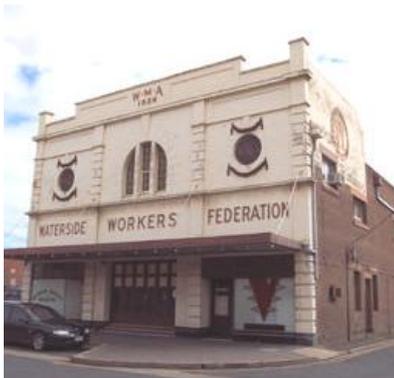
Capitol Theatre, Peterborough 91926)  
– very similar in design and detail to  
WWF Hall

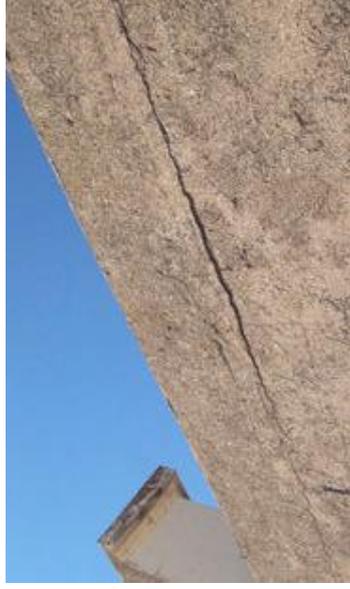
South parapet – to be assessed for seismic stability – note also horizontal cracking due to expansion of embedded metal straps

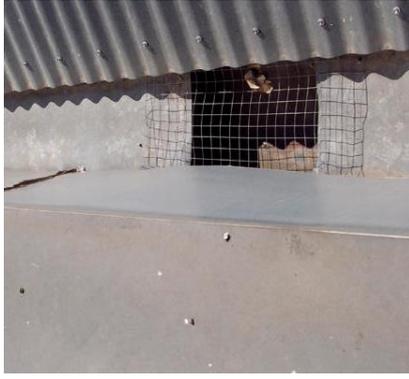
Typical sump box in box gutter – depth as little as 70mm in places

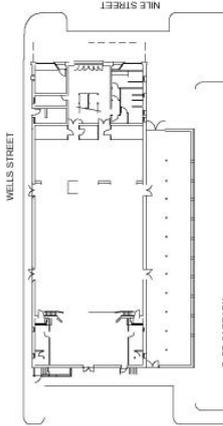
## ALTERATIONS / NON SIGNIFICANT FABRIC/ DILAPIDATION

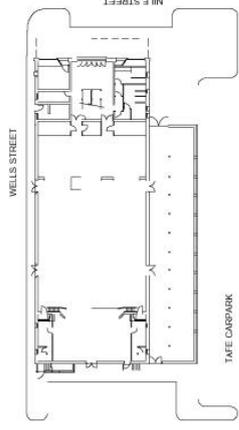
## ALTERATIONS / NON SIGNIFICANT FABRIC/ DILAPIDATION

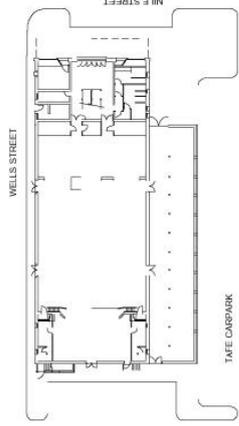
**ALTERATIONS / NON SIGNIFICANT FABRIC/ DILAPIDATION**

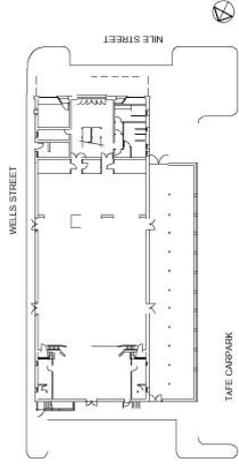
## ALTERATIONS / NON SIGNIFICANT FABRIC/ DILAPIDATION

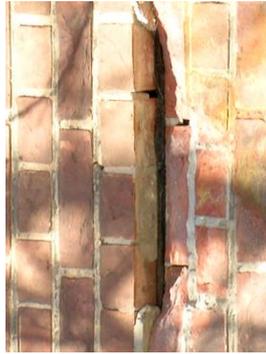
Failure of brickwork – where embedded steel corroding

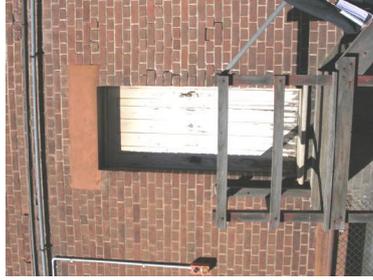
Rear egress door to stage

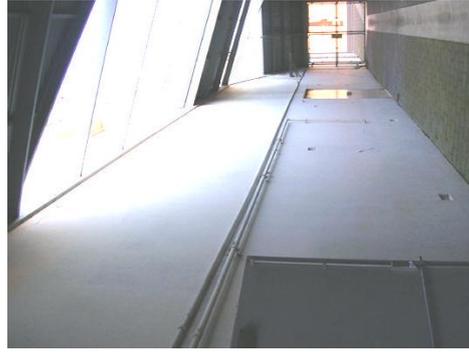
Store structure against wall

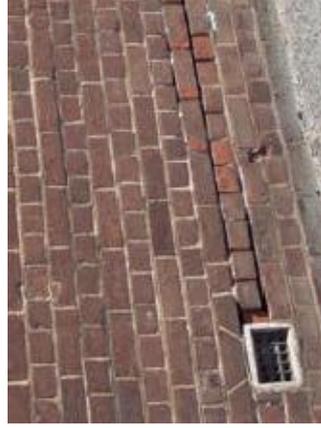
Rising damp damage to wall – bituminous DPC at top of floor vent.

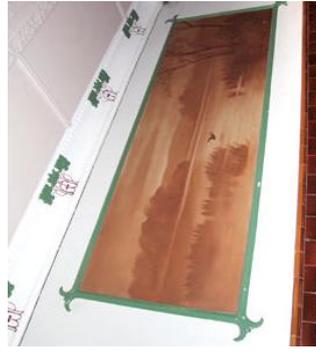
Painted wall mural 'lake scene'

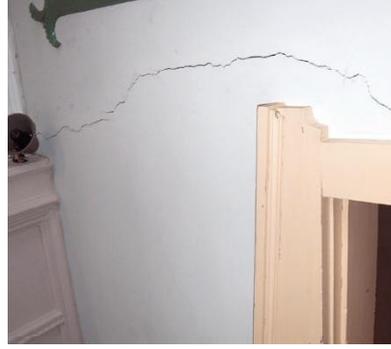
Crack – door to store (east side)

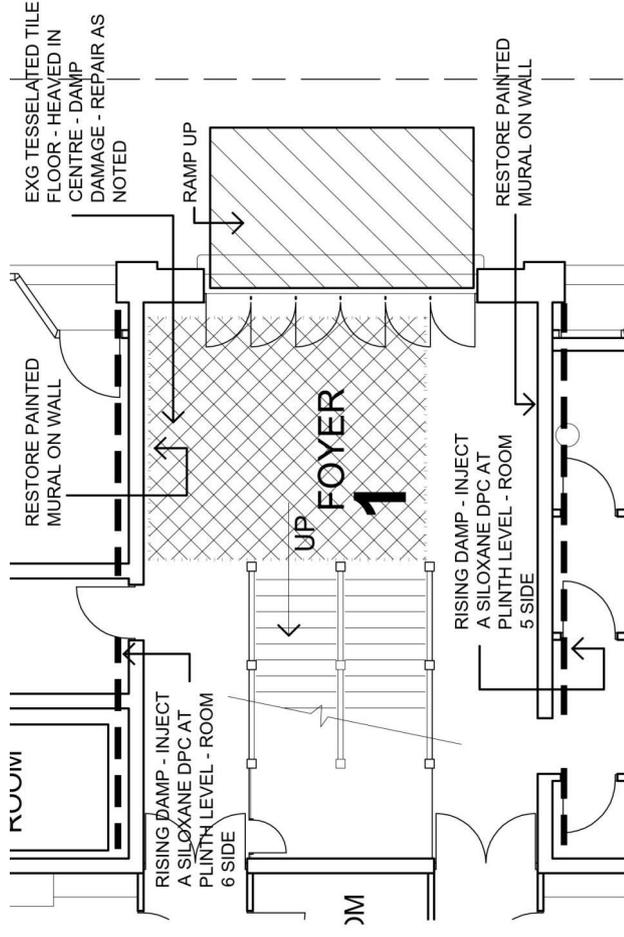
# (Fmr) Waterside Workers Federation Hall Conservation Plan

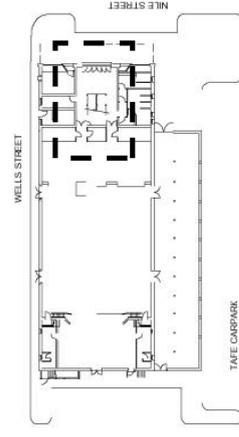
## ALTERATIONS / NON SIGNIFICANT FABRIC/ DILAPIDATION

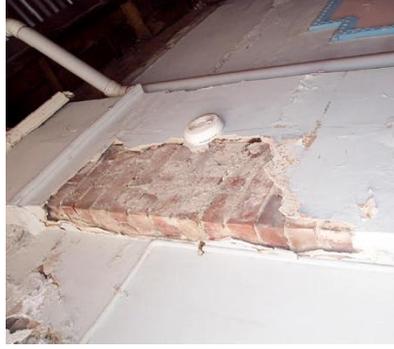
Typical failure of plaster – at cornice level, with corroded conduit behind

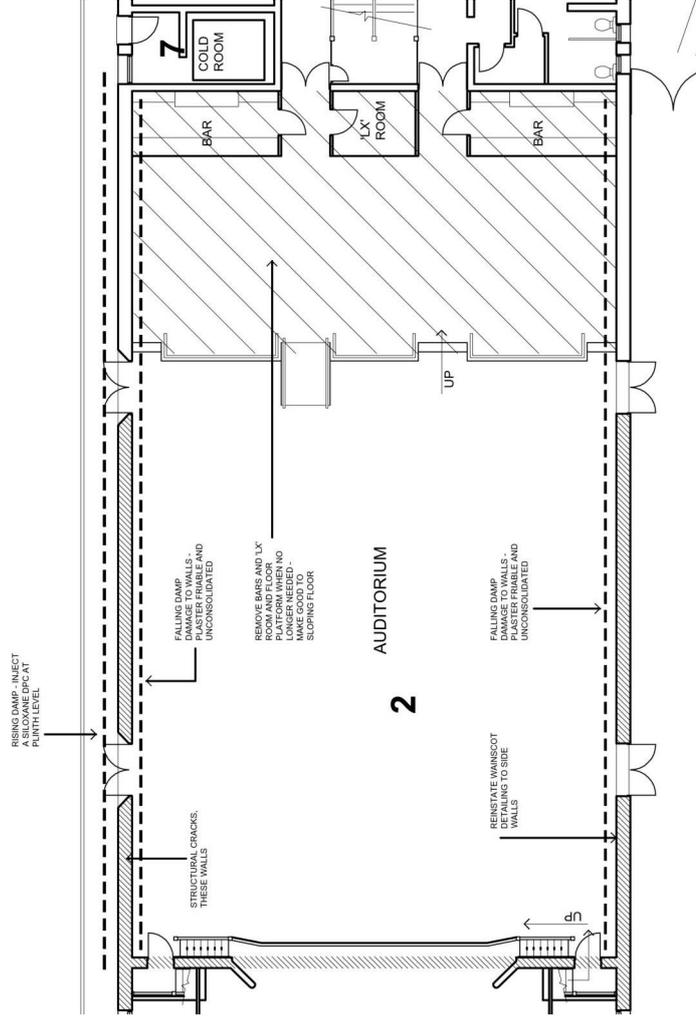
# (Fmr) Waterside Workers Federation Hall Conservation Plan

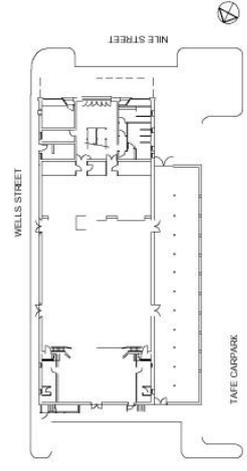
## ALTERATIONS / NON SIGNIFICANT FABRIC/ DILAPIDATION

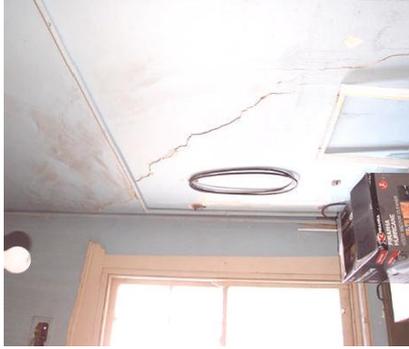
Cracking, south wall

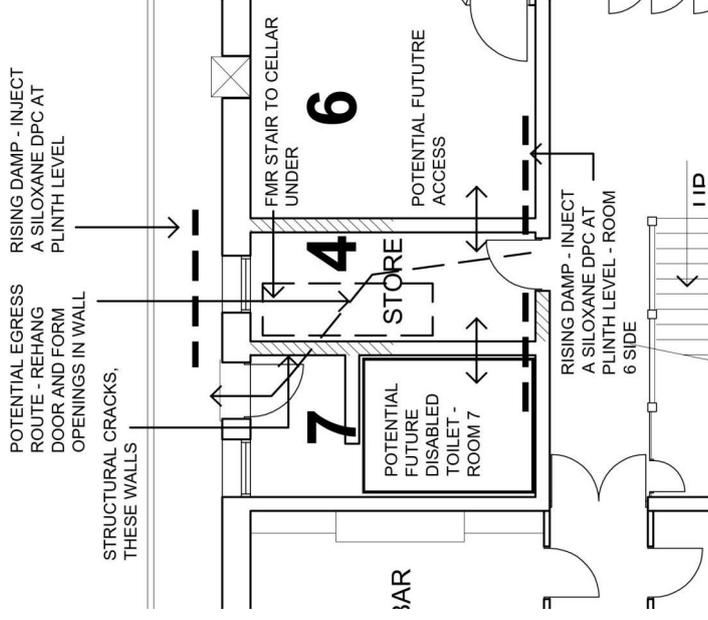
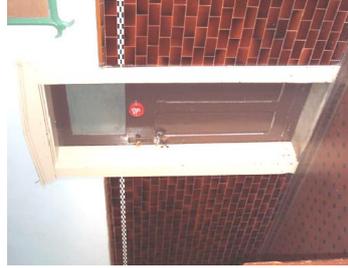
Door to room, from Foyer

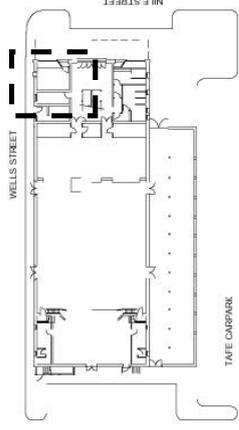
## ALTERATIONS / NON SIGNIFICANT FABRIC/ DILAPIDATION

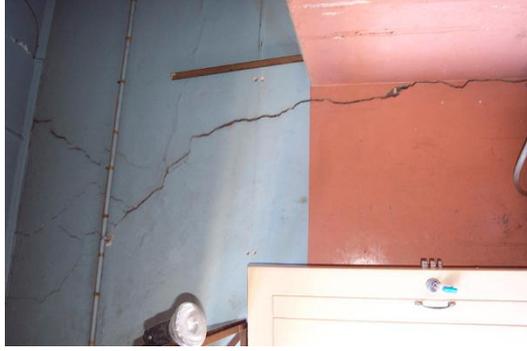
Structural crack – south wall (north same)

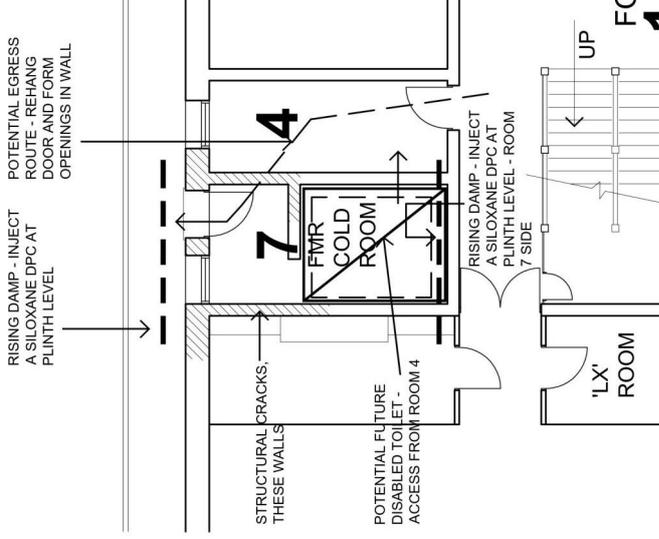
# (Fmr) Waterside Workers Federation Hall Conservation Plan

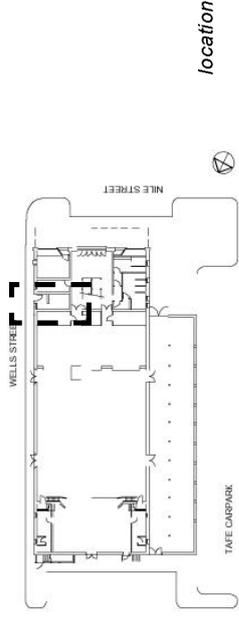
## ALTERATIONS / NON SIGNIFICANT FABRIC/ DILAPIDATION

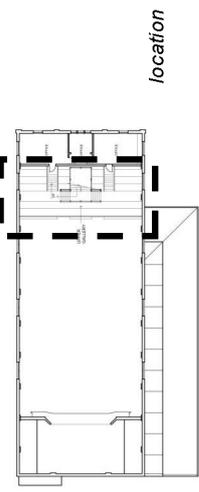
Refer 5.0 Discussion of Cultural Significance for details regarding the Heritage Value table
